MARS – Lessons Learned

MARS Report No 383 September 2024

Work from height fatality

As edited from NSIA (Norway) report MARINE 2024/04

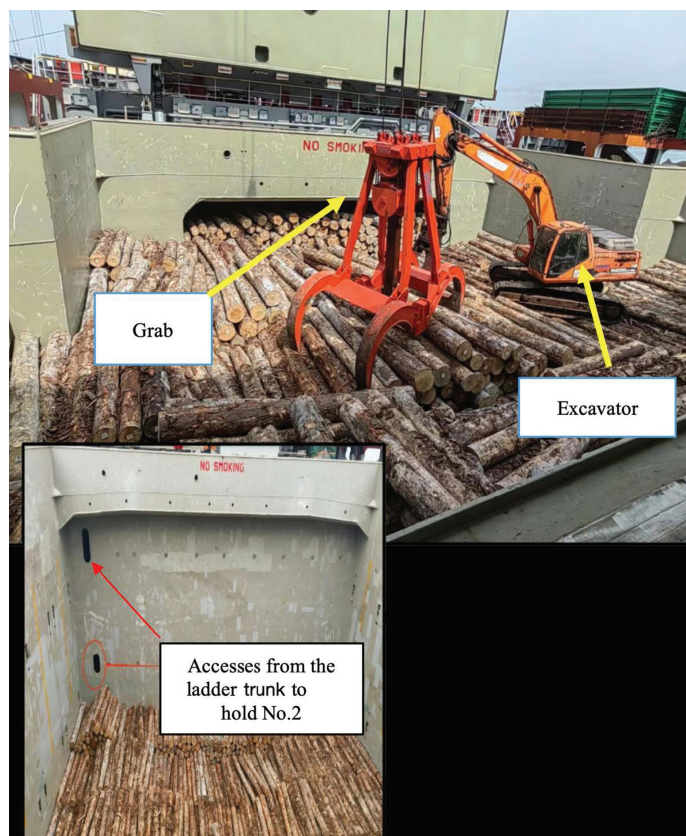
The investigation found, among other things, that the hold access trunk contained an O₂ concentration of only 3%, and 1.3 ppm of phosphine (a fumigation product). The level of carbon monoxide exceeded the upper range of the gas detector. The report found that if proper access controls to the entrance to the ladder trunks had been in place, the fatal accident might have been avoided.

The investigation also found that the initial actions taken by the crew in response to the emergency in the ladder trunk were not properly organised and failed to follow recommended practices. For example, the mask worn by the C/O during his solo improvised rescue attempt was only to filter toxic gases but did not provide survivable oxygen. In short, the crew were not familiar with the limitations of the mask respirator. It could be deduced that the shipboard safety training and drills for enclosed space entry and rescue were ineffective.

- Proper gas testing cannot be undertaken in six minutes using gas detectors and certainly not by using chickens.
- This accident is a prime example of a vessel's leaders bowing to the pressures of shore stevedores. A vessel's crew, by virtue of its company's SMS, are bound to ensure compliance with the enclosed space procedures on their vessel. In this case gas testing, enclosed space access, and victim rescue were all either ignored, outsourced or not properly carried out.
