MARITIME FEEDBACK

Issue 65
November 2021

An independent and confidential reporting system for the maritime industry

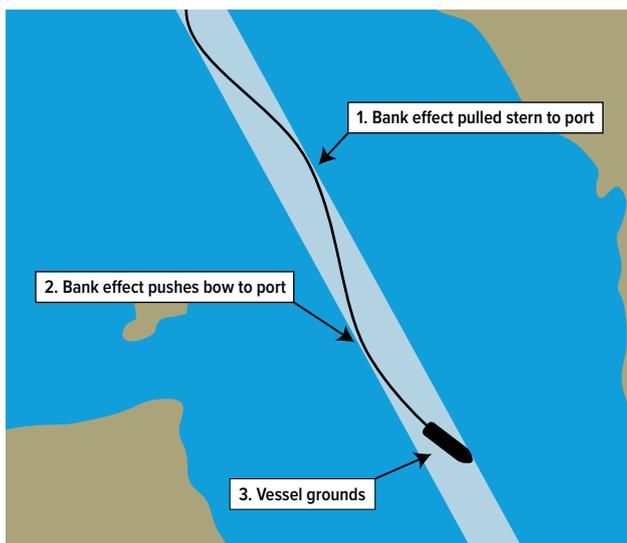
The tanker was transiting a canal with 2 pilots on the bridge in addition to the master, chief officer, helm and lookout. The pilot ordered a turn to starboard later than planned, but this was not challenged by the bridge team. As the vessel approached the channel's port side the *bank effect* pulled the stern to port just as starboard rudder was applied. In combination, these caused the vessel to cross to the channel's starboard side where bank effect pushed the bow to port. The vessel re-crossed the channel and touched bottom on her port side, breaching the water ballast tanks.

The vessel's track at the time of the incident is shown on the ECDIS screenshot below.

The latent causes of this incident were in place long before the vessel touched bottom. During the planning stage, the available depth of water and the narrow breadth of the channel should have prompted the master and navigator to consider the possibility that *bank effect* and *squat* could affect manoeuvrability and to determine the speed at which these might take effect. If this speed was below the minimum steerage speed, then the use of tugs should have been considered. The need for tugs should have been revisited during the master/pilot exchange (see IMO Resolution A.960(23) Annex 2 for more details).

It appears that neither the pilot nor the bridge team recognized that the vessel was experiencing the bank effect after the bow's initial swing to starboard, or if they did, they did not take corrective action (e.g., slowing the vessel's speed).

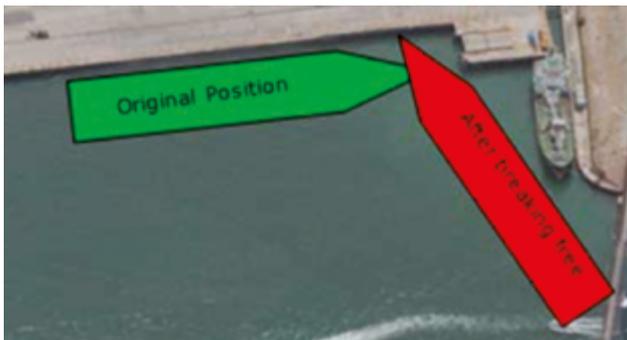
While not an exact science, it is possible to estimate the likely forces generated by high winds on a high-sided vessel so long as the windage area is known

An investigation revealed that the mooring bollard to which the stern lines of both vessels were attached had been pulled completely out of its foundations due to the wind loading on the side of the vessels. It also concluded that the crew could not have prevented the incident.

Placing all the stern ropes onto one bollard created a single point of failure which was aggravated when the second vessel secured to the same bollard. Either vessel could have identified this latent risk, as could the supervisor of the line-handling party. It is possible that neither the port authority nor the master understood the risk which had been created. There is no evidence of a discussion regarding the possibility of the vessel moving to an

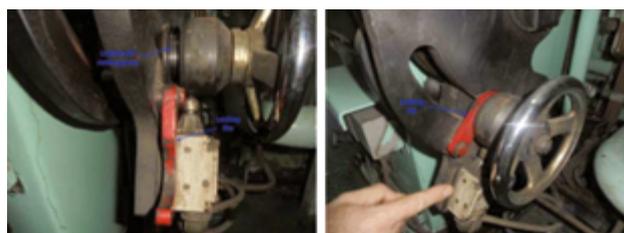
The emergency manoeuvring system located on the side of the engine is fitted with a locking arrangement which under normal conditions rests firmly inside the groove indicated in the photos below.

The investigation revealed that the direct cause of this incident was the disengagement of the emergency manoeuvring system's locking arrangement.

The root causes for this incident were found to be a lack of understanding of the risks by the engineering officers carrying out the checks, which were not overseen by a supervising officer – a procedural requirement that is stated in the SMS procedures for working on critical equipment. It is likely therefore that the engineering officers failed to appreciate the criticality and impact of the locking system.

In this case, there appears to be a fundamental design flaw with this equipment, given that it can be vibrated out of its secured position when the engine is running.

Critical equipment defined in the company SMS must be inspected on completion of any maintenance by a

supervising officer. Crucially, single points of failure must also be checked as part of routine pre-arrival and pre-departure checks.
