Arrogance, or Ignorance?

This edition of *Maritime FEEDBACK* contains a wide variety of interesting and often alarming reports, and we are extremely grateful to our reporters for sharing them with us.

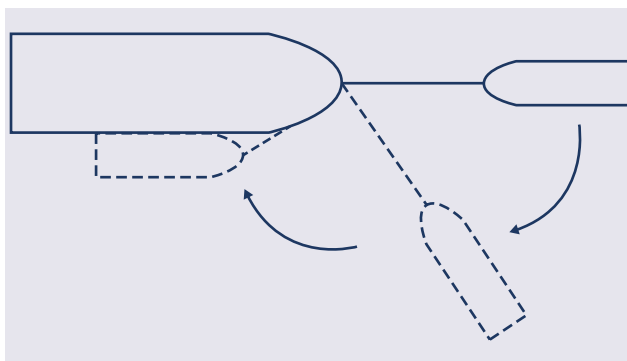
Figure 1: Likely response of a tug to engine failure

As the chief pilot prepared to make a planned alteration of course, both engines of the tug attached to the centre lead forward failed within minutes of each other, and the tug was overtaken and pulled hard against the LNG carrier's bow by the towing line.

A combination of the sea state and the tug's ballast arrangement was found to have caused the sea chest to become starved of cooling water for the generators, which were automatically shut down to preserve the equipment.

Tugs sometimes undertake bow-to-bow (reverse) towing because it keeps their propellers further away from the pressure fields around the towed vessel's bow. This method also ensures that if the tug propulsion fails (as in this incident), it is pulled alongside the towed vessel by its bow, which reduces the risk of capsizing.

However, when reverse-towing (as in this incident), there is a risk that the tug becomes trimmed by the bow, lifting the stern (and sea-chest water intake) out of the water and starving the sea chest of cooling water to the generators. This risk is lessened by towing more slowly, adjusting the vessel's trim, and ensuring that the sea chest vents are open so that any air trapped inside can be expelled to allow it to re-fill.

The automatic shut-down system protects the equipment from overheating and being damaged or even catching fire. However, many systems do not have a manual override for use in emergencies. Tug vessel operators are advised to investigate how their equipment would react in a similar scenario, whether it would alert the operators before shutting down, and then develop emergency procedures accordingly. A checklist that includes the operating area (open water, sheltered water), draft and trim, ballast arrangement, and type of towing for the job will ensure that the risks of a blackout are mitigated.
