MARITIME FEEDBACK

Issue 66
February 2022

An independent and confidential reporting system for the maritime industry

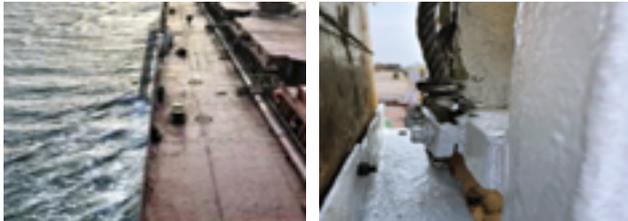
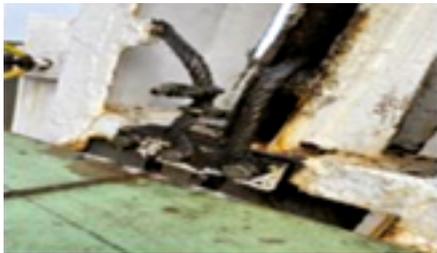
A pilot boarded a ship using a combination rig. After their embarkation, and while the accommodation ladder was being recovered, the wire falls parted, and the accommodation ladder dropped to the sea and trailed in the water as the vessel was underway to the port. The Master alerted the pilot to what had happened when the pilot reached the bridge.

A subsequent inspection revealed that the bolts securing the wire had failed. A full port state control inspection took place the next day following a report on the incident. The accommodation ladder had been inspected by a classification society 18 months earlier.

Many vessels, especially bulk carriers and tankers, have accommodation ladders that are positioned on exposed areas of the main deck where heavy seas and spray, combined with cargo residue and dust, can affect the fixtures and fittings and bring about accelerated corrosion. Access is often difficult, hampering inspections and maintenance. Design is a significant latent factor in this incident, which could have had extremely severe consequences for the pilot.

The Master undertook remedial action with respect to the accommodation ladder and the fall securing.

Reducing the periodicity for changing the falls to between 18 and 30 months for vessels that have accommodation ladders in these exposed areas should be considered, as should changes to the design for securing the falls. However, thorough maintenance must always be provided to the wires, sheaves and fixtures no matter how difficult the access to the wires may be.

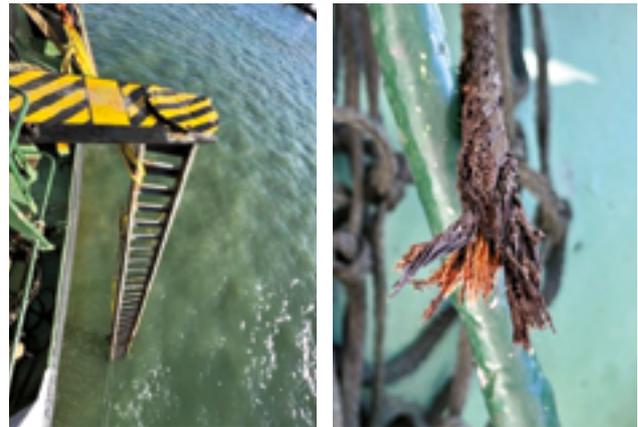
The photographs shown below highlight another failure of a gangway that has just occurred at the time of writing this report where the gangway wire had parted just after the pilot boarded the vessel.

SOLAS regulation II-1/3-9 states that all wires used to support the means of embarkation and disembarkation shall be maintained as specified in SOLAS regulation III/20.4 which states that falls should be 'renewed when necessary due to the deterioration of the falls or at intervals of not more than 5 years, whichever is the earlier'.

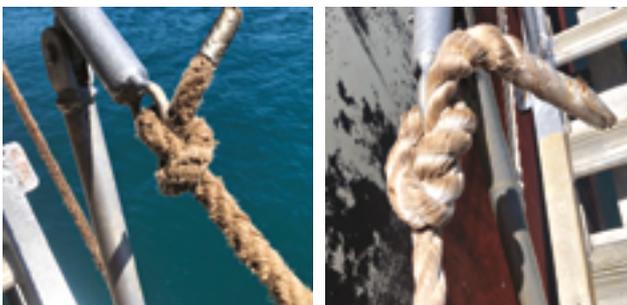
While boarding a vessel at sea a pilot found that the combination ladder was affixed solely by overhand knots (see pictures). These easily unravel if there is strain from the standing part of the rope, e.g., under the weight of a pilot as they ascend or descend the ladder. This type of knot must never be used in the rigging of a pilot ladder or gangway.

The repeated use of overhand knots in this case indicates that either the officer did not correctly supervise and inspect, or that the crew have become desensitized to a deviance from standard procedures: the local practice on the ship or within the company for securing the pilot ladder rope with an overhand knot had become the accepted norm.

Despite being incorrect there appears to be no culture of challenge by the crew or officers to secure the ropework with the correct knot.

The correct knot in these circumstances is either a round turn and two half hitches or a bowline. The rigging of a gangway which is to be used as part of a combination ladder arrangement is a task normally undertaken by 2-3 deck crew. It should then be inspected by the officer detailed to meet the pilot.

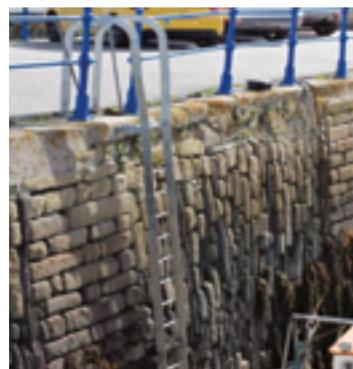
A fisher returned to their vessel with a guest in the late evening after they had met ashore. Both had drunk alcohol. It was low tide, and the vessel was approximately 6m below the quay edge due to the tidal range in that port.

As they climbed down the vertical quayside ladder, the guest fell off the ladder and hit the vessel's hull before falling, injured, into the water. The sea temperature was approximately 10° C (50° F).

Design (latent factor) – Vertical ladders are exposed to the elements and prone to damage by vessels berthed alongside. There is no fall protection inherent within the design and unless regularly maintained they are prone to rusting and marine growth

Fit for duty – Alcohol increases the likelihood of an incident occurring and *CHIRP* recommends that Safety Management System (SMS) risk assessments include alcohol/intoxication as a factor when appropriate, particularly in cases where access arrangements include a climb up and down vertical ladders.

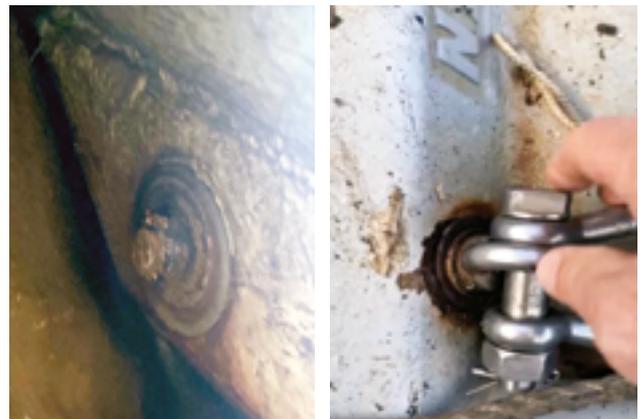
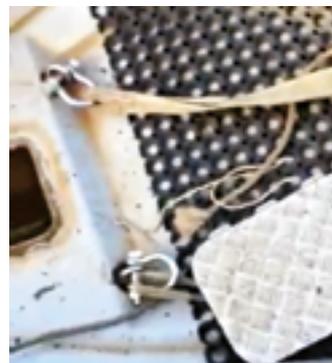
A new crew member inspected the ship's lifesaving equipment to familiarise themselves with the equipment on board. They discovered that the lifting eyes in the ship's workboat were damaged and loose, which meant it was not the eyes carrying the load but a length of threaded bar which appeared poorly maintained. If the lifting eyes had failed while the boat was being lifted it could have resulted in serious injury to the two crew members who are ordinarily inside when it is lowered into the water.

The condition of the items in the photographs suggest that neither inspection nor maintenance routines were effective, and that the boat's crew were either unaware that the lifting eyes were in a dangerous condition or did not feel empowered to report their concerns.

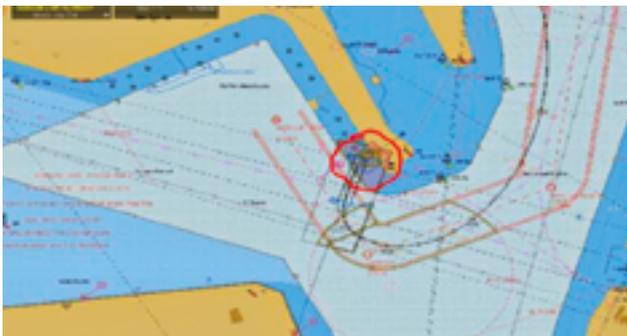
As it passed the mooring dolphin, the vessel turned short round to port, assisted by the tugs. About 5 minutes later the officer at the stern alerted the bridge that the vessel was drifting towards the end of the breakwater. The current was running in an easterly direction during the turn to port, which caused the drift, although the pilot believed that it was running in a westerly direction. The pilot gave several engine orders from dead slow to full ahead to increase the distance from the breakwater, but a noise was heard on the port quarter. Following checks within the engine room to ensure the hull was not breached, the vessel berthed port side alongside at the oil terminal.

Given that the pilot had intimate knowledge of this port and berth and had been briefed on the tide and current conditions, this was a skill-based error. However, it was not challenged by anyone else on the bridge, including the master, nor the masters of the attached tugs. A group-think scenario had developed because everyone placed too much implicit trust in the pilot.

Several opportunities to ensure that the pilot and bridge team were equally aware of the environmental conditions were missed. The bridge team would almost certainly have held an entering-harbour brief on approach to the port at which tide and current would have been discussed. The master-pilot exchange provided a second opportunity to discuss the direction of tide. Assuming that the pilot was providing a running commentary to the master as to his intentions (*CHIRP* recognises that this does not always occur, particularly where language barriers exist) then the choice of a turn to port could have been challenged prior to the turn commencing.

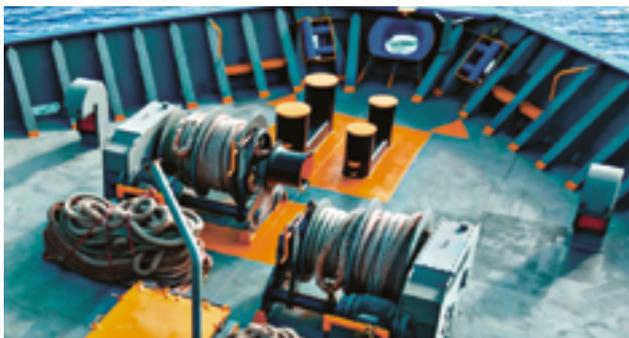
An ordinary seaman (OS) eased the tug's mooring rope out through the closed chock (Panama lead) and had taken a turn of the messenger rope around the bitts. As the tanker turned to starboard to align itself with the berth the tug's line was in the water and as the separation between the tanker's bow and the tug increased, the messenger line paid out at an increased speed which was not anticipated by the line handlers.

The officer in charge of the mooring operation warned the OS to step clear from the messenger rope. The OS attempted to do so but slipped on the deck and became entangled with the rope which dragged him overboard through the Panama chock. The OS was recovered from the water by the tug and resuscitation and first aid was immediately administered until the ambulance took them to hospital. Tragically the OS died the next day.

Situational Awareness – Mooring operations can evolve rapidly and maintaining situational awareness during mooring operations is vital to ensure that everyone remains safe. Anticipation is key: lines can unexpectedly become taut or even break, creating a lethal snap-back hazard; winch brakes can fail or ropes be pulled overboard due to the relative motion of the vessel and the tug or bollard ashore.

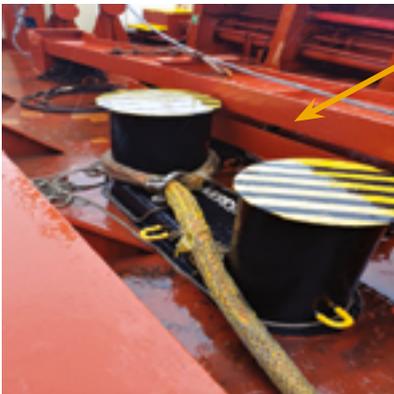
Log stanchion in lowered position

A lumber carrier embarked a pilot as it approached a loading berth where a tug waited to assist. The pilot requested that the vessel secure the tug's line to the mooring bits on the forward deck. After this was achieved, and as the tug came under the line to push up, the tug master realised that his line had been improperly secured: it had been wrapped around the bits and secured with a shackle, rather than the eye being dropped over the top of the bits.

When questioned the master explained that, when lowered, the log stanchions were so close to the bits that they obstructed the bits. The master was informed that they should not use a shackle in future, and that the bits should not be used when the log stanchions were lowered.

The vessel is relatively new, and the deck layout has not been modified since she was built. This suggests that the improper placement of the log stanchion and mooring bits is the product of poor design. This is known as a latent error, and CHIRP believes that there is a high probability that incidents will continue to occur on the vessel because the mooring bits cannot correctly and safely be used as intended. The likelihood of an incident is further increased because of the proximity of the bulwark brackets which create a trip hazard.

The trip hazard and inability to correctly work the mooring bits are evident, and CHIRP is concerned that these had seemingly not been detected either during commissioning trials, during flag and class inspections, or by the crew themselves. CHIRP is also concerned that other vessels of the same design might also contain the same latent design hazards.
