MARITIME FEEDBACK

Issue 65
November 2021

An independent and confidential reporting system for the maritime industry

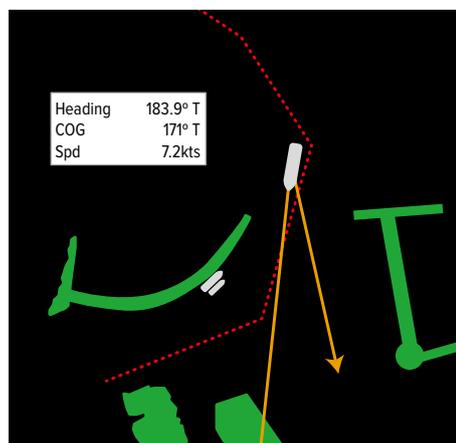
As the vessel entered the breakwater at a speed of 8.3 knots and was swinging to starboard the main engine was stopped. The pilot ordered hard to port and dead slow ahead as the vessel continued to swing to starboard, but the main engine failed to respond. The vessel's speed was now 7.2 knots.

The pilot ordered bow thruster full to port, although the master advised it would be ineffective at speeds over 6 knots. Vessel speed at this time was 6.5 knots and the pilot ordered an anchor be readied to let go while the engine control was transferred to the Engine Control Room (ECR). Thereafter engine movements were attempted from the ECR, but all attempts failed.

The vessel's speed was still above 5 knots, so the pilot ordered that both anchors be let go. The vessel speed had

reduced to 4.5 knots when it contacted a barge that had been berthed outboard of another.
